**Town of Bedford**

# Wastewater Asset Condition Assessment and Valuation

June 2011

**Malcolm Pirnie, Inc.**

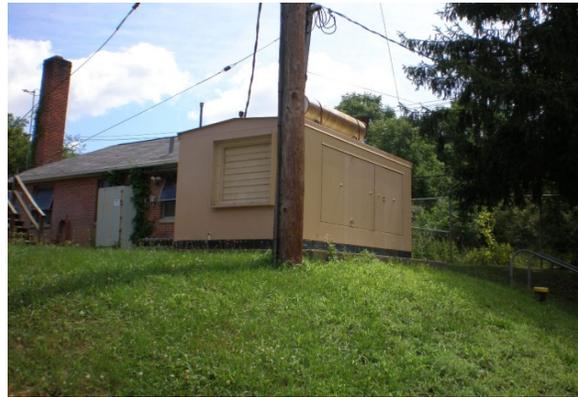
Equipment Description	<u>Generator (Main Plant)</u>
Manufacturer	<u>Kohler</u>
Model Number	<u>80PROZJ81</u>
Quantity/Type	<u>1 / Diesel</u>
Equipment IDs	<u></u>
Installation Date	<u>1995</u>
Capacity	<u>130 kW</u>
Motor Manuf.	<u></u>
HP/RPM/V/FLA	<u></u>
Drive Type	<u></u>
Other	<u>120/208V</u>

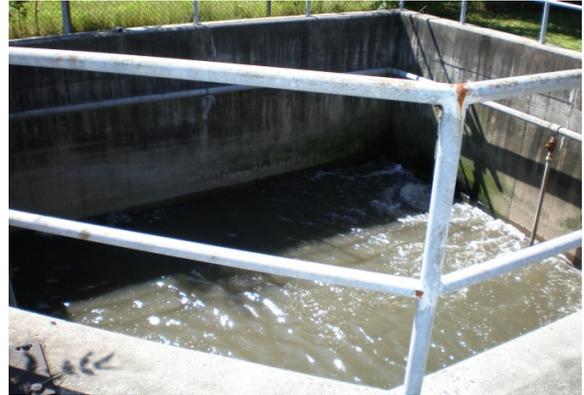
Equipment Description Equalization Basin No.2  
 Coarse Bubble Diffusers  
 Manufacturer \_\_\_\_\_  
 Model Number \_\_\_\_\_  
 Quantity/Type \_\_\_\_\_ / \_\_\_\_\_  
 Equipment IDs \_\_\_\_\_  
 Installation Date 1995  
 Capacity \_\_\_\_\_  
 Motor Manuf. \_\_\_\_\_  
 HP/RPM/V/FLA \_\_\_\_\_  
 Drive Type \_\_\_\_\_  
 Other \_\_\_\_\_

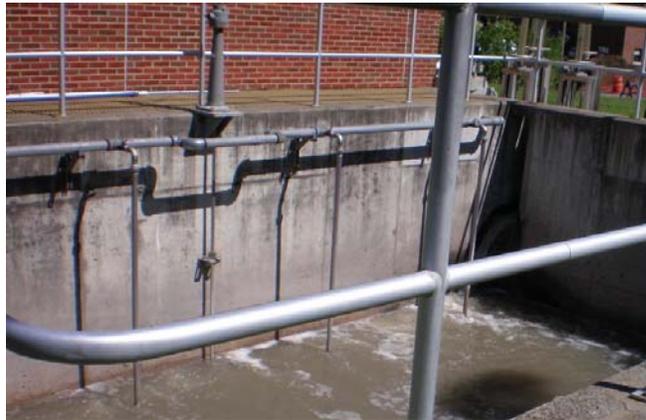
Equipment Description Equalization Basin No.1  
 Coarse Bubble Diffusers  
 Manufacturer \_\_\_\_\_  
 Model Number \_\_\_\_\_  
 Quantity/Type \_\_\_\_\_ / \_\_\_\_\_  
 Equipment IDs \_\_\_\_\_  
 Installation Date 2002  
 Capacity \_\_\_\_\_  
 Motor Manuf. \_\_\_\_\_  
 HP/RPM/V/FLA \_\_\_\_\_  
 Drive Type \_\_\_\_\_  
 Other \_\_\_\_\_

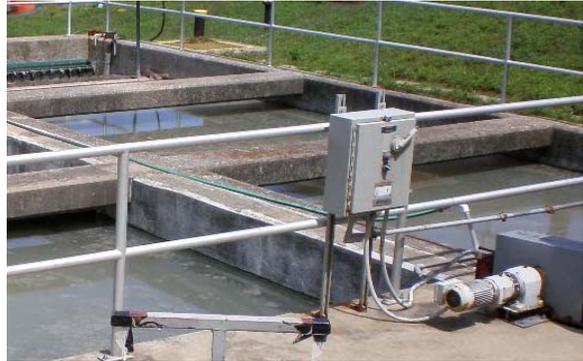
Equipment Description Primary Clarifier No.2- Flight and Drive  
 Manufacturer \_\_\_\_\_  
 Model Number \_\_\_\_\_  
 Quantity/Type /  
 Equipment IDs \_\_\_\_\_  
 Installation Date \_\_\_\_\_  
 Capacity \_\_\_\_\_  
 Motor Manuf. \_\_\_\_\_  
 HP/RPM/V/FLA 1/2 hp  
 Drive Type \_\_\_\_\_  
 Other \_\_\_\_\_

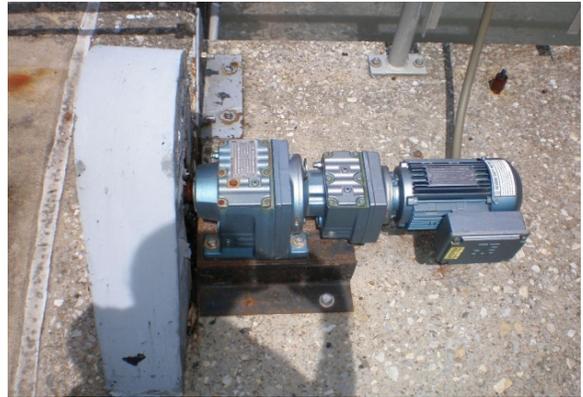
Equipment Description Primary Clarifier No.1- Flight and Drive  
 Manufacturer \_\_\_\_\_  
 Model Number \_\_\_\_\_  
 Quantity/Type /  
 Equipment IDs \_\_\_\_\_  
 Installation Date \_\_\_\_\_  
 Capacity \_\_\_\_\_  
 Motor Manuf. \_\_\_\_\_  
 HP/RPM/V/FLA 1/2  
 Drive Type \_\_\_\_\_  
 Other \_\_\_\_\_

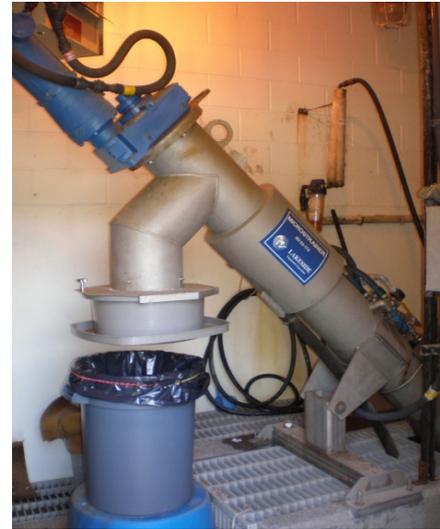
Equipment Description Rotary Fine Screen Taconic  
 Manufacturer Romat Fine Screen  
 Model Number 16MS-0.250-75  
 Quantity/Type 1  
 Equipment IDs \_\_\_\_\_  
 Installation Date 2004  
 Capacity 1270 gpm  
 Motor Manuf. Lakeside Equipment Corp.  
 HP/RPM/V/FLA \_\_\_\_\_  
 Drive Type \_\_\_\_\_  
 Other \_\_\_\_\_

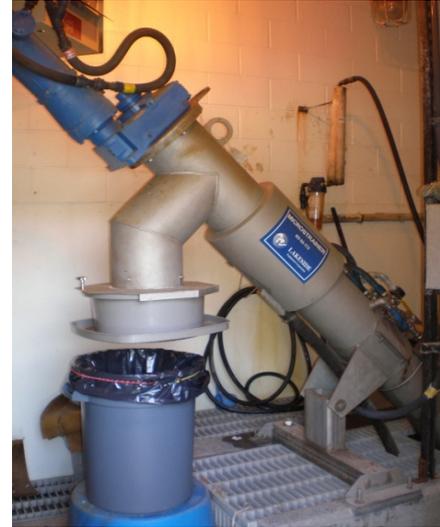
Equipment Description Rotary Fine Screen Bedford  
 Manufacturer Romat Fine Screen  
 Model Number 16MS-0.250-75  
 Quantity/Type 1  
 Equipment IDs \_\_\_\_\_  
 Installation Date 2004  
 Capacity 1270 gpm  
 Motor Manuf. Lakeside Equipment Corp.  
 HP/RPM/V/FLA \_\_\_\_\_  
 Drive Type \_\_\_\_\_  
 Other \_\_\_\_\_

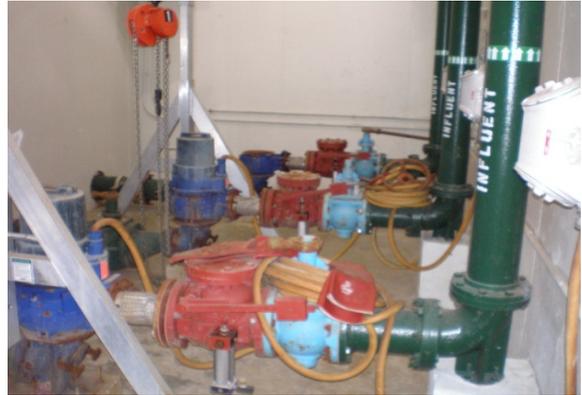
Equipment Description Influent Pumps  
 Manufacturer KSB  
 Model Number KRTK 100-251-190-1750 RPM  
 Quantity/Type 3 / Submersible  
 Equipment IDs \_\_\_\_\_  
 Installation Date \_\_\_\_\_  
 Capacity 85-350 gpm @ 26'TDH  
 Motor Manuf. \_\_\_\_\_  
 HP/RPM/V/FLA 10HP  
 Drive Type \_\_\_\_\_  
 Other \_\_\_\_\_

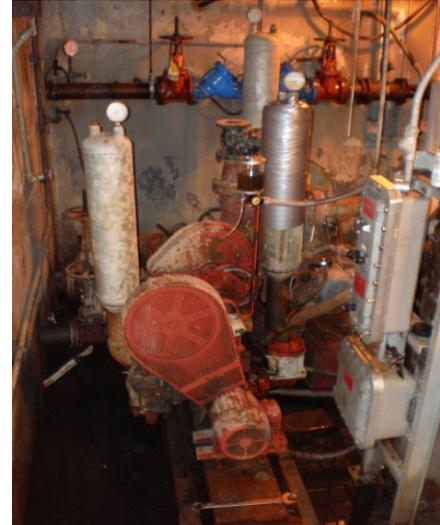
controller. Only one sludge pump is in operating condition at this time. The other two sludge pumps have been scavenged for parts to keep one pump in operation.

Equipment Description Sludge Pumps  
 Manufacturer ITT Marlow, Inc  
 Model Number PE61-A  
 Quantity/Type 3 / Dual Plunger  
 Equipment IDs \_\_\_\_\_  
 Installation Date \_\_\_\_\_  
 Capacity 57gpm @ 62 strokes/min @ 60'TDH  
 Motor Manuf. \_\_\_\_\_  
 HP/RPM/V/FLA 1.5HP  
 Drive Type \_\_\_\_\_  
 Other \_\_\_\_\_

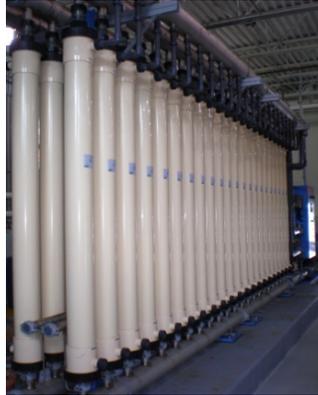
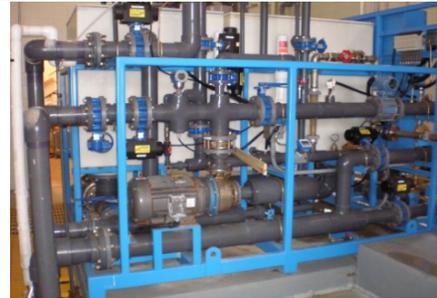
Equipment Description Microfiltration System  
 Manufacturer Pall Corp  
 Model Number \_\_\_\_\_  
 Quantity/Type 3 Racks/ 44 module/rack (membranes are <0.1 micron pore size)  
 Equipment IDs \_\_\_\_\_  
 Installation Date \_\_\_\_\_  
 Capacity \_\_\_\_\_  
 Motor Manuf. Goulds: (2 Feed Pumps; 3 Recirc Pumps; 3 Filtration Pumps)  
 HP/RPM/V/FLA \_\_\_\_\_  
 Drive Type \_\_\_\_\_

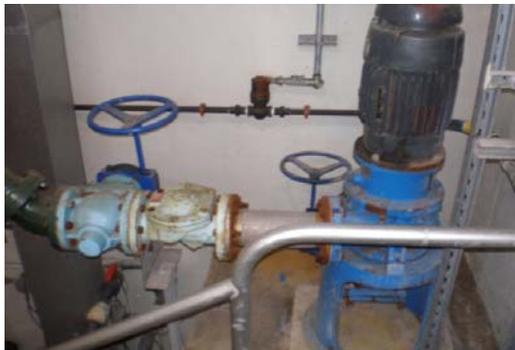
Equipment Description	Magnetic Flow Meters
Manufacturer	Doppler
Model Number	UFM 91
Quantity	2
Installation Date	
Equipment ID	
Voltage	
Output	
Other
