**Town of Bedford**

# Wastewater Asset Condition Assessment and Valuation

June 2011

**Malcolm Pirnie, Inc.**

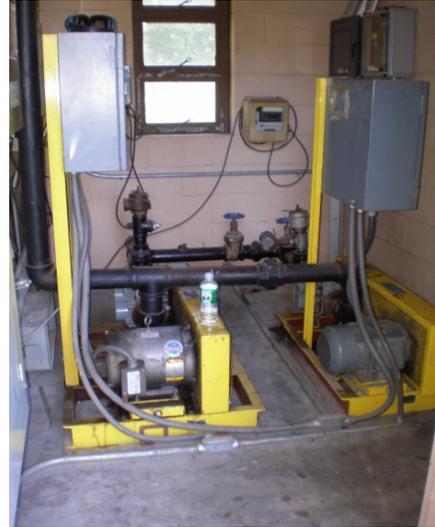
Equipment Description Equalization Blower No.  
 Manufacturer WispAir  
 Model Number \_\_\_\_\_  
 Quantity/Type /  
 Equipment IDs \_\_\_\_\_  
 Installation Date \_\_\_\_\_  
 Capacity \_\_\_\_\_  
 Motor Manuf. \_\_\_\_\_  
 HP/RPM/V/FLA \_\_\_\_\_  
 Drive Type \_\_\_\_\_  
 Other \_\_\_\_\_

<u>Condition</u>	1-5/NA	Comment(s)
Corrosion	2	
Leakage	1	
Vibration/Noise	2	Rotary- noisy by design, some reduction could be useful
Support/Base Damage	1	
Paint/Coating Damage	2	
Labeling Missing (Y/N)	NA	
Other

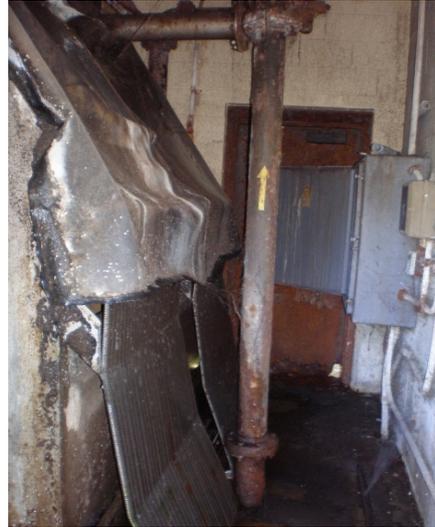
<u>Condition</u>	1-5/NA	Comment(s)
Corrosion	4	
Leakage	3	
Vibration/Noise	NA	
Support/Base Damage	3	
Paint/Coating Damage	4	
Labeling Missing (Y/N)	Y	
Other	NA

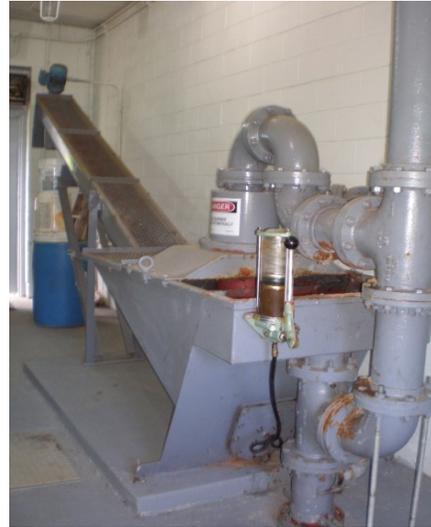
Equipment Description Grit Classifier  
 Manufacturer Waste Tech  
 Model Number \_\_\_\_\_  
 Quantity/Type 1 /  
 Equipment IDs \_\_\_\_\_  
 Installation Date \_\_\_\_\_  
 Capacity \_\_\_\_\_  
 Motor Manuf. \_\_\_\_\_  
 HP/RPM/V/FLA \_\_\_\_\_  
 Drive Type \_\_\_\_\_  
 Other \_\_\_\_\_

<u>Condition</u>	1-5/NA	Comment(s)
Corrosion	2	
Leakage	1	
Vibration/Noise	1	
Support/Base Damage	1	
Paint/Coating Damage	2	
Labeling Missing (Y/N)	Y	
Other	NA

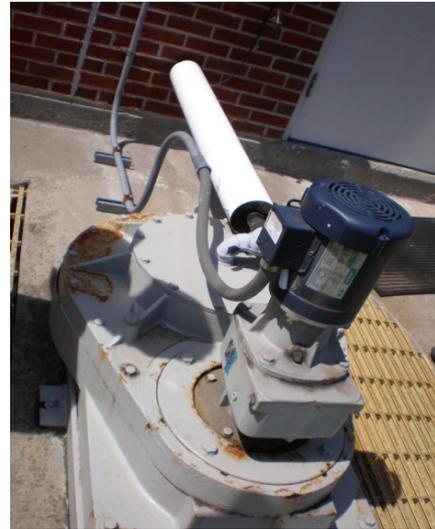
Equipment Description	<u>Vortex Grit Separator</u>
Manufacturer	<u>Hayward Gordon</u>
Model Number	<u>CR4-7</u>
Quantity/Type	<u>1 /</u>
Equipment IDs	<u></u>
Installation Date	<u></u>
Capacity	<u>250 gpm @26' TDH</u>
Motor Manuf.	<u>TEFC</u>
HP/RPM/V/FLA	<u>10HP</u>
Drive Type	<u></u>
Other	<u></u>

<u>Condition</u>	1-5/NA	Comment(s)
Corrosion	3	
Leakage	NA	
Vibration/Noise	1	
Support/Base Damage	2	
Paint/Coating Damage	3	
Labeling Missing (Y/N)	NA	
Other	NA

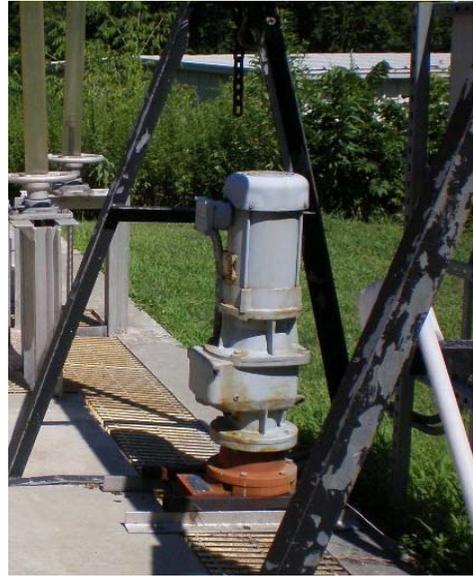
<u>Condition</u>	1-5/NA	Comment(s)
Corrosion	2	
Leakage	NA	
Vibration/Noise	NA	
Support/Base Damage	1	
Paint/Coating Damage	2	
Labeling Missing (Y/N)	NA	
Other	NA

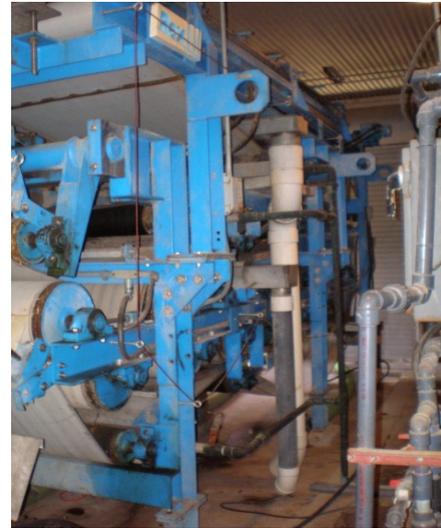
Equipment Description Belt Filter Press  
 Manufacturer \_\_\_\_\_  
 Model Number \_\_\_\_\_  
 Quantity/Type /  
 Equipment IDs \_\_\_\_\_  
 Installation Date \_\_\_\_\_  
 Capacity \_\_\_\_\_  
 Motor Manuf. \_\_\_\_\_  
 HP/RPM/V/FLA \_\_\_\_\_  
 Drive Type \_\_\_\_\_  
 Other \_\_\_\_\_

<u>Condition</u>	1-5/NA	Comment(s)
Corrosion	2	
Leakage	NA	
Vibration/Noise	NA	
Support/Base Damage	2	
Paint/Coating Damage	2	
Labeling Missing (Y/N)	NA	
Other

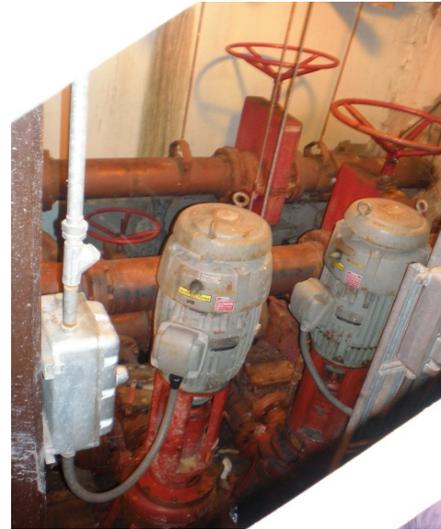
<u>Condition</u>	1-5/NA	Comment(s)
Corrosion	3	
Leakage	2	
Vibration/Noise	NA	
Support/Base Damage	3	
Paint/Coating Damage	3	
Labeling Missing (Y/N)	Y	
Other

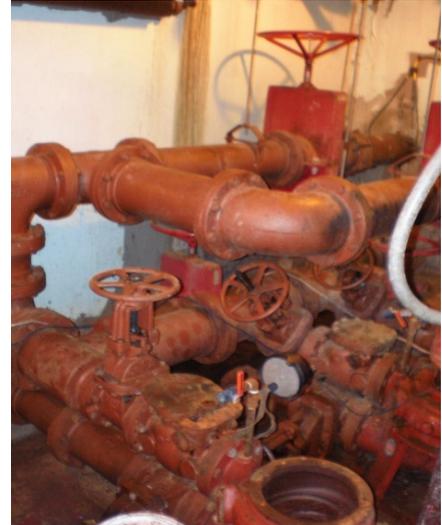
<u>Condition</u>	1-5/NA	Comment(s)
Corrosion	3	
Leakage	2	
Vibration/Noise	NA	
Support/Base Damage	3	
Paint/Coating Damage	3	
Labeling Missing (Y/N)	Y	
Other		
<u>Ancillary Items</u>	1-5/NA	Comment(s)
Piping/Valves	3	
Motors	3	
Instruments	NA	
Local Control Station/Panel	NA	
Other

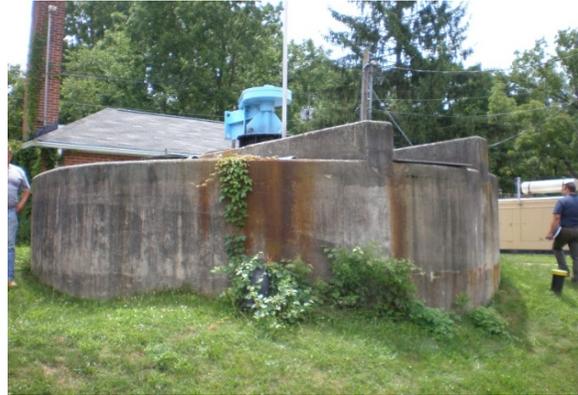
<u>Condition</u>	1-5/NA	Comment(s)
Corrosion	3	
Leakage	NA	
Vibration/Noise	NA	
Support/Base Damage	NA	
Paint/Coating Damage	3	
Labeling Missing (Y/N)	Y	
Other

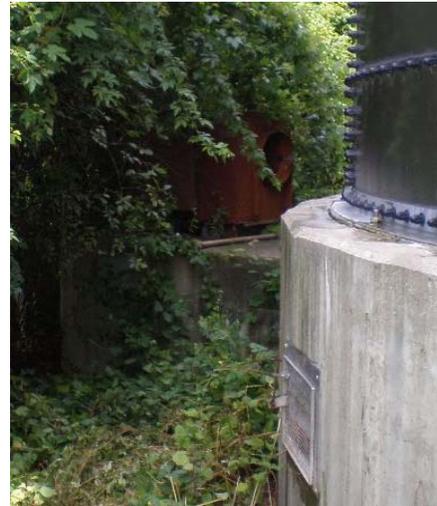
<u>Condition</u>	1-5/NA	Comment(s)
Corrosion	5	
Leakage	NA	
Vibration/Noise	NA	OOS
Support/Base Damage	4	
Paint/Coating Damage	5	
Labeling Missing (Y/N)	Y	
Other

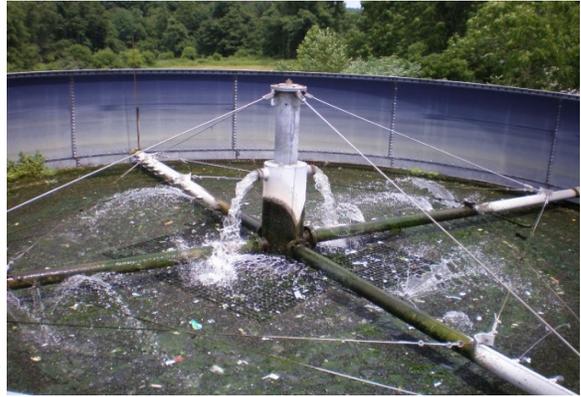
<u>Condition</u>	1-5/NA	Comment(s)
Corrosion	3	
Leakage	NA	
Vibration/Noise	NA	
Support/Base Damage	NA	
Paint/Coating Damage	NA	
Labeling Missing (Y/N)	Y	
Other

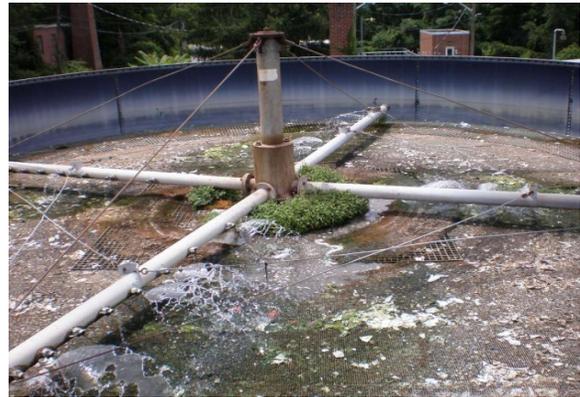
<u>Condition</u>	1-5/NA	Comment(s)
Corrosion	3	
Leakage	NA	
Vibration/Noise	NA	
Support/Base Damage	NA	
Paint/Coating Damage	NA	
Labeling Missing (Y/N)	Y	
Other

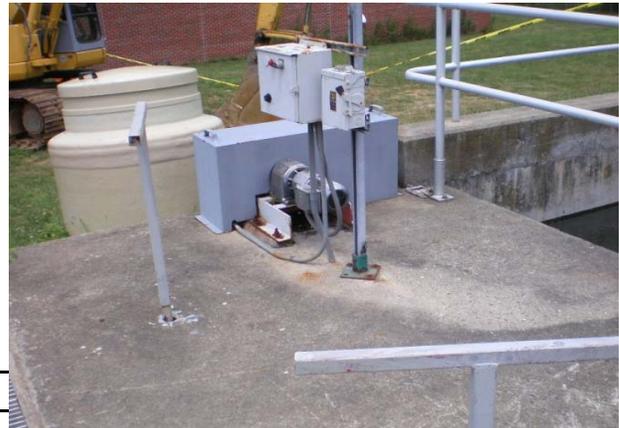
<u>Condition</u>	1-5/NA	Comment(s)
Corrosion	2	
Leakage	NA	
Vibration/Noise	1	
Support/Base Damage	2	
Paint/Coating Damage	2	
Labeling Missing (Y/N)	Y	
Other

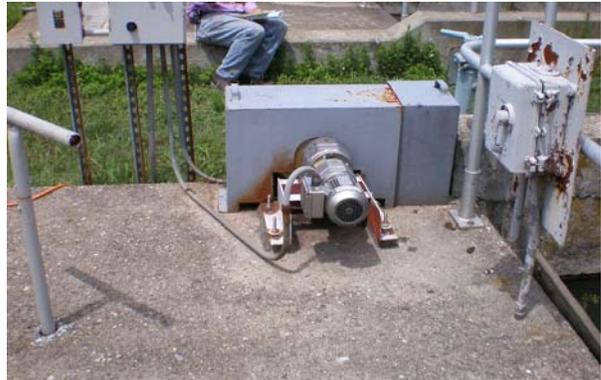
<u>Condition</u>	1-5/NA	Comment(s)
Corrosion	4	
Leakage	NA	
Vibration/Noise	NA	Not operating
Support/Base Damage	3	
Paint/Coating Damage	4	
Labeling Missing (Y/N)	Y	
Other

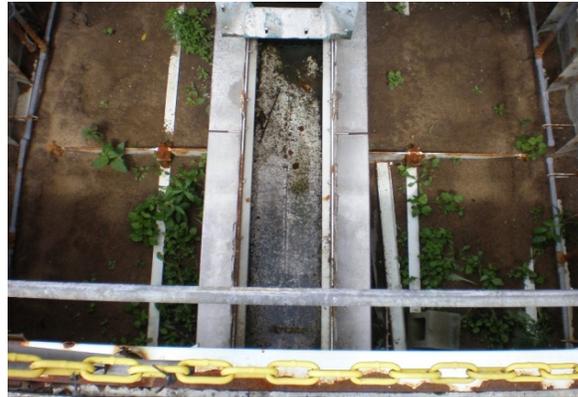
Equipment Description Rapid Sand Filters  
 Manufacturer \_\_\_\_\_  
 Model Number \_\_\_\_\_  
 Quantity/Type 3 /  
 Equipment IDs \_\_\_\_\_  
 Installation Date \_\_\_\_\_  
 Capacity \_\_\_\_\_  
 Motor Manuf. \_\_\_\_\_  
 HP/RPM/V/FLA \_\_\_\_\_  
 Drive Type \_\_\_\_\_  
 Other \_\_\_\_\_

<u>Condition</u>	1-5/NA	Comment(s)
Corrosion	4	
Leakage	NA	
Vibration/Noise	NA	
Support/Base Damage	NA	
Paint/Coating Damage	4	
Labeling Missing (Y/N)	N	
Other

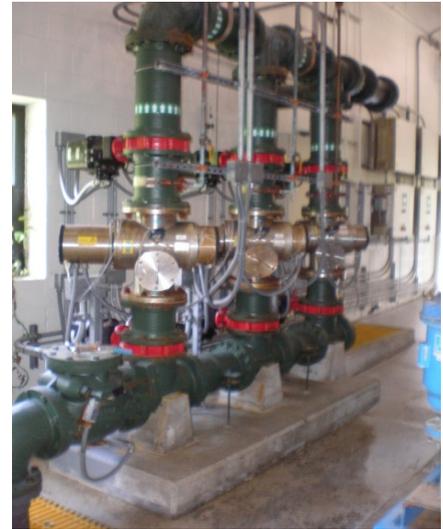
Equipment Description UV System  
 Manufacturer \_\_\_\_\_  
 Model Number \_\_\_\_\_  
 Quantity/Type 3 /  
 Equipment IDs \_\_\_\_\_  
 Installation Date \_\_\_\_\_  
 Capacity \_\_\_\_\_  
 Motor Manuf. MP Pumps Series 30  
 HP/RPM/V/FLA \_\_\_\_\_  
 Drive Type \_\_\_\_\_  
 Other \_\_\_\_\_

<u>Condition</u>	1-5/NA	Comment(s)
Corrosion	2	
Leakage	1	
Vibration/Noise	1	
Support/Base Damage	2	
Paint/Coating Damage	2	
Labeling Missing (Y/N)	N	
Other

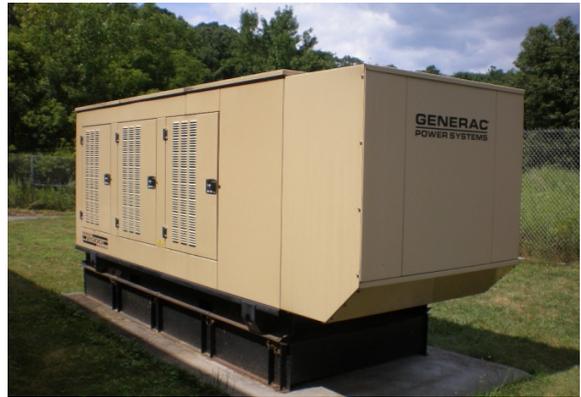
<u>Condition</u>	1-5/NA	Comment(s)
Corrosion	1	
Leakage	1	
Vibration/Noise	NA	
Support/Base Damage	1	
Paint/Coating Damage	1	
Labeling Missing (Y/N)	N	
Other

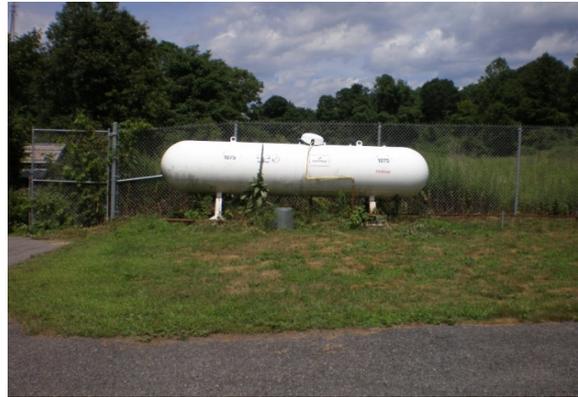
Equipment Description Propane Tank  
 Manufacturer \_\_\_\_\_  
 Model Number \_\_\_\_\_  
 Quantity/Type /  
 Equipment IDs \_\_\_\_\_  
 Installation Date \_\_\_\_\_  
 Capacity \_\_\_\_\_  
 Motor Manuf. \_\_\_\_\_  
 HP/RPM/V/FLA \_\_\_\_\_  
 Drive Type \_\_\_\_\_  
 Other \_\_\_\_\_

<u>Condition</u>	1-5/NA	Comment(s)
Corrosion	1	
Leakage	1	
Vibration/Noise	NA	
Support/Base Damage	1	
Paint/Coating Damage	2	
Labeling Missing (Y/N)	N	
Other

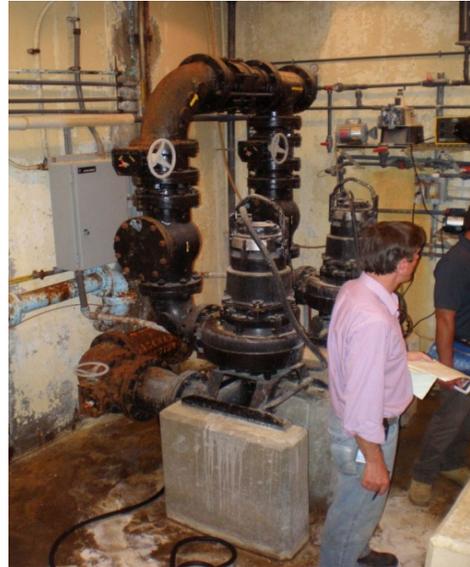
<u>Condition</u>	1-5/NA	Comment(s)
Corrosion	2	
Leakage	2	
Vibration/Noise	2	
Support/Base Damage	2	
Paint/Coating Damage	2	
Labeling Missing (Y/N)	NA	
Other

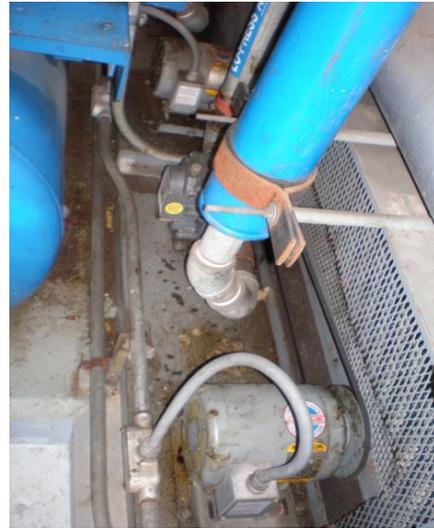
<u>Condition</u>	1-5/NA	Comment(s)
Corrosion	2	
Leakage	1	
Vibration/Noise	1	
Support/Base Damage	2	
Paint/Coating Damage	2	
Labeling Missing (Y/N)	NA	
Other

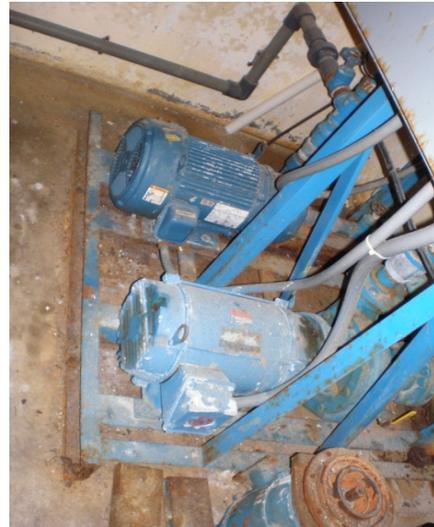
Equipment Description Domestic Water Pumps  
 Manufacturer \_\_\_\_\_  
 Model Number \_\_\_\_\_  
 Quantity/Type 2 /  
 Equipment IDs \_\_\_\_\_  
 Installation Date \_\_\_\_\_  
 Capacity \_\_\_\_\_  
 Motor Manuf. \_\_\_\_\_  
 HP/RPM/V/FLA \_\_\_\_\_  
 Drive Type \_\_\_\_\_  
 Other \_\_\_\_\_

<u>Condition</u>	1-5/NA	Comment(s)
Corrosion	3	
Leakage	1	
Vibration/Noise	NA	
Support/Base Damage	2	
Paint/Coating Damage	2	
Labeling Missing (Y/N)	NA	
Other

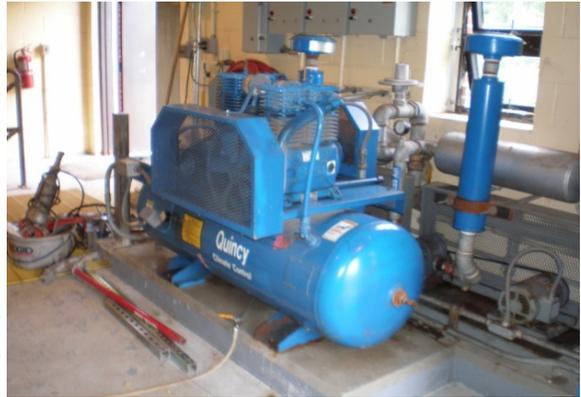
Equipment Description Filter Air Compressor  
 Manufacturer \_\_\_\_\_  
 Model Number \_\_\_\_\_  
 Quantity/Type /  
 Equipment IDs \_\_\_\_\_  
 Installation Date \_\_\_\_\_  
 Capacity \_\_\_\_\_  
 Motor Manuf. \_\_\_\_\_  
 HP/RPM/V/FLA \_\_\_\_\_  
 Drive Type \_\_\_\_\_  
 Other \_\_\_\_\_

<u>Condition</u>	1-5/NA	Comment(s)
Corrosion	2	
Leakage	1	
Vibration/Noise	1	
Support/Base Damage	2	
Paint/Coating Damage	1	
Labeling Missing (Y/N)	NA	
Other

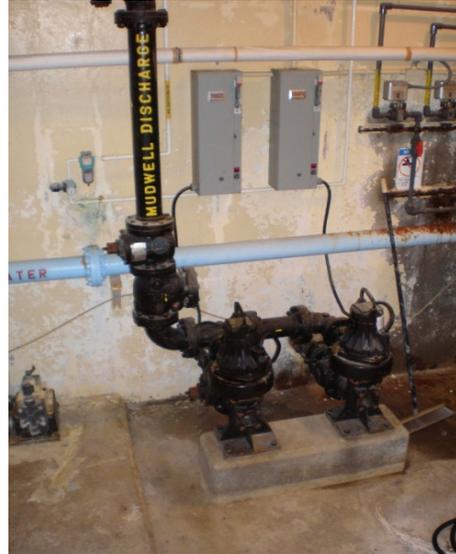
<u>Condition</u>	1-5/NA	Comment(s)
Corrosion	2	
Leakage	1	
Vibration/Noise	1	
Support/Base Damage	2	
Paint/Coating Damage	2	
Labeling Missing (Y/N)	NA	
Other

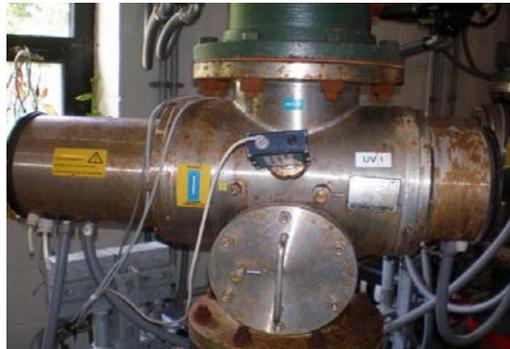
Equipment Description	<u>UV Transmitter</u>
Manufacturer	_____
Model Number	_____
Quantity	_____
Installation Date	_____
Equipment ID	_____
Voltage	_____
Output	_____
Other	_____

<u>Condition</u>	1-5/NA	Comment(s)
Corrosion	2	
Leakage/Water Damage	1	
Vibration / Noise	NA	
Supports / Base Damage	NA	
Leakage	1	
Covers/Doors Missing/Damaged	1	
Connections Loose/Broken	1	
Drawings/Labeling Missing	1	
Insulation Wear	1	
Evidence of Overheating	NR	
Grounding Missing/Damaged	NR	
Cooling System Broken	NA	
Door Mounted Inst. Damage	1	
Other

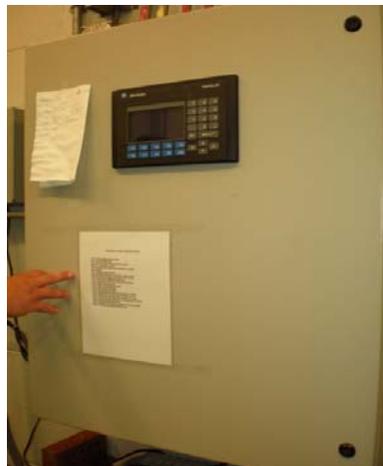
Equipment Description Dial Out Panel  
 Manufacturer \_\_\_\_\_  
 Model Number \_\_\_\_\_  
 Quantity \_\_\_\_\_  
 Installation Date \_\_\_\_\_  
 Equipment ID \_\_\_\_\_  
 Voltage \_\_\_\_\_  
 Output \_\_\_\_\_  
 Other \_\_\_\_\_

<u>Condition</u>	1-5/NA	Comment(s)
Corrosion	NA	
Leakage/Water Damage	NA	
Vibration / Noise	NA	
Supports / Base Damage	NA	
Leakage	NA	
Covers/Doors Missing/Damaged	1	
Connections Loose/Broken	1	
Drawings/Labeling Missing	1	
Insulation Wear	1	
Evidence of Overheating	NR	
Grounding Missing/Damaged	NR	
Cooling System Broken	NA	
Door Mounted Inst. Damage	1	
Other

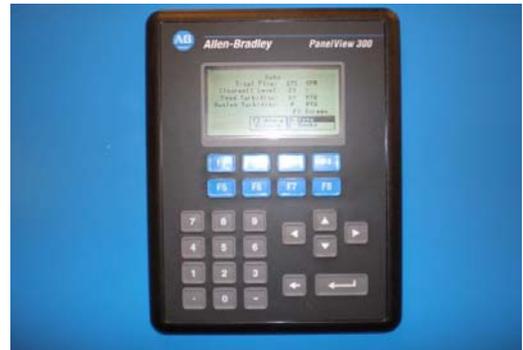
Equipment Description	SCADA
Manufacturer	Allen Bradley
Model Number	
Quantity	
Installation Date	
Equipment ID	
Voltage	
Output	
Other

<u>Condition</u>	1-5/NA	Comment(s)
Corrosion	NA	
Leakage/Water Damage	NA	
Vibration / Noise	NA	
Supports / Base Damage	NA	
Leakage	NA	
Covers/Doors Missing/Damaged	1	
Connections Loose/Broken	1	
Drawings/Labeling Missing	1	
Insulation Wear	1	
Evidence of Overheating	NR	
Grounding Missing/Damaged	NR	
Cooling System Broken	NA	
Door Mounted Inst. Damage	1	
Other

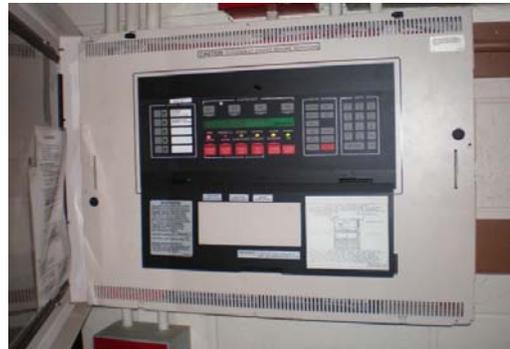
Equipment Description	Fire Panel
Manufacturer	_____
Model Number	_____
Quantity	_____
Installation Date	_____
Equipment ID	_____
Voltage	_____
Output	_____
Other	_____

<u>Condition</u>	1-5/NA	Comment(s)
Corrosion	NA	
Leakage/Water Damage	NA	
Vibration / Noise	NA	
Supports / Base Damage	NA	
Leakage	NA	
Covers/Doors Missing/Damaged	1	
Connections Loose/Broken	1	
Drawings/Labeling Missing	1	
Insulation Wear	1	
Evidence of Overheating	NR	
Grounding Missing/Damaged	NR	
Cooling System Broken	NA	
Door Mounted Inst. Damage	1	
Other

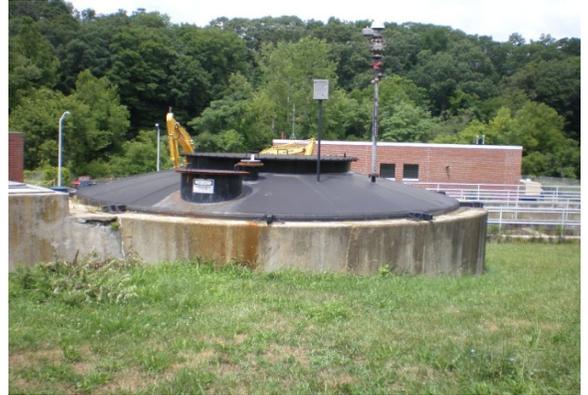
Structure Description	Digester No. 2 (North)	
Use	OOS	
Type Of Construction	Steel/ Concrete	
Year Built		
LxWxH (above grade)	x	x
Basement Dimensions

Condition	1-5/NA	Comment(s)			
Concrete/Masonry	Corrosion		2				
	Leakage		2				
	Cracking		2				
	Spalling		2	5 - in some areas			
	Settling		1				
	Joint Damage/Failure		NA				
	Exposed Reinfcmnt/Aggreg.		NA				
	Pitting		2				
	Delamination		2				
	Freeze/Thaw Damage		2				
					<b>Ancillary Items</b>	1-5/NA	Comment(s)
Steel	Corrosion		3	Dome heavy corrosion	Railings	NA	
	Loss of Section		2		Walkways	NA	
	Cracking		2		Platforms	NA	
	Deformation		2		Stairs/Ladders	NA	
	Fatigue		2		Hatches/Doors	NA	
	Connection Failure		2		Supports	NA	
				Cathodic Prot.	NA

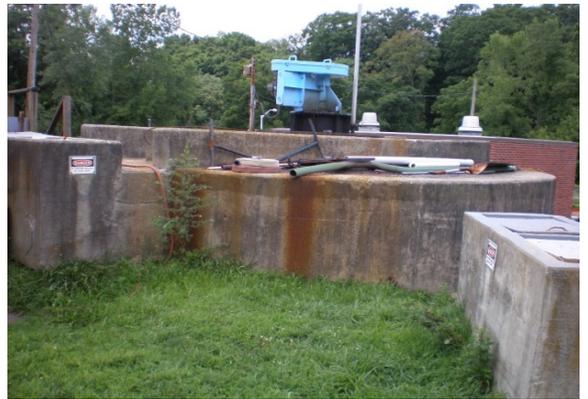
Structure Description	Digester No. 1 (South)	
Use	Storage	
Type Of Construction	Steel/ Concrete	
Year Built	_____	
LxWxH (above grade)	x	x
Basement Dimensions	_____

Condition	1-5/NA	Comment(s)
Concrete/Masonry	Corrosion		4	
	Leakage		2	
	Cracking		3	
	Spalling		5	
	Settling		2	
	Joint Damage/Failure		2	
	Exposed Reinfcmnt/Aggreg.		4	
	Pitting		3	
	Delamination		3	
	Freeze/Thaw Damage		3	Top only
	Steel	Corrosion		3
Loss of Section			1	
Cracking			1	
Deformation			1	
Fatigue			1	
Connection Failure			1	
		<b>Ancillary Items</b>	1-5/NA	Comment(s)
		Railings	NA	Should have railings
		Walkways	NA	
		Platforms	NA	
		Stairs/Ladders	5	Wooden stairs poor.
		Hatches/Doors	5	
		Supports	NA	
		Cathodic Prot.	NA

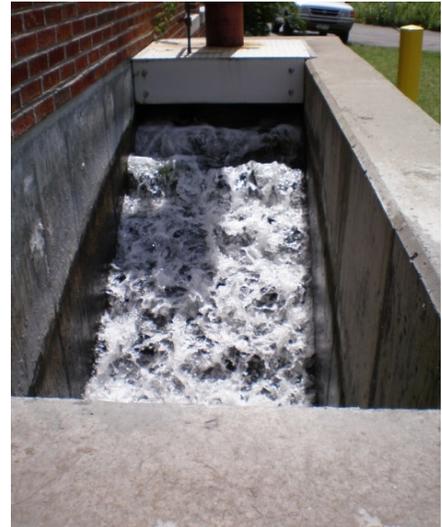
Structure Description	Post-aeration Casade	
Use	Aeration	
Type Of Construction	Concrete	
Year Built		
LxWxH (above grade)	x	x
Basement Dimensions

Condition	1-5/NA	Comment(s)			
Concrete/Masonry	Corrosion		1				
	Leakage		1				
	Cracking		1				
	Spalling		2				
	Settling		1				
	Joint Damage/Failure		1				
	Exposed Reinfcmnt/Aggreg.		2				
	Pitting		1				
	Delamination		1				
	Freeze/Thaw Damage		1				
					<b>Ancillary Items</b>	1-5/NA	Comment(s)
Steel	Corrosion		NA		Railings	NA	
	Loss of Section		NA		Walkways	NA	
	Cracking		NA		Platforms	NA	
	Deformation		NA		Stairs/Ladders	NA	
	Fatigue		NA		Hatches/Doors	NA	
	Connection Failure		NA		Supports	NA	
				Cathodic Prot.	NA

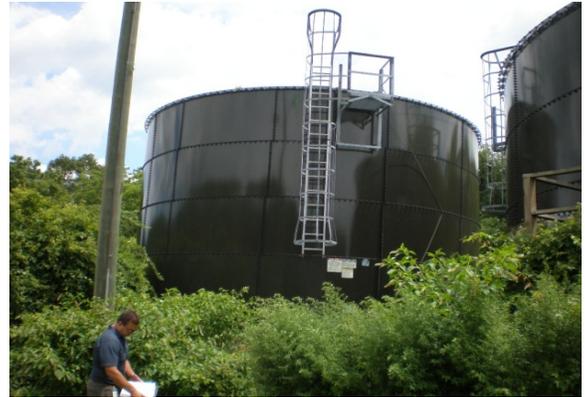
Structure Description	Trickling Filter No.2	
Use	Filtration	
Type Of Construction	Steel/ Concrete	
Year Built	_____	
LxWxH (above grade)	x	x
Basement Dimensions	_____

Condition	1-5/NA	Comment(s)	
Concrete/Masonry	Corrosion		1		
	Leakage		3		
	Cracking		2		
	Spalling		1		
	Settling		1		
	Joint Damage/Failure		NA		
	Exposed Reinfcmnt/Aggreg.		1		
	Pitting		1		
	Delamination		NA		
	Freeze/Thaw Damage		NA		
Steel	Corrosion		1		
	Loss of Section		1		
	Cracking		1		
	Deformation		1		
	Fatigue		1		
	Connection Failure		1		
			<b>Ancillary Items</b>	1-5/	Comment(s)
			Railings	2	
		Walkways	NA		
		Platforms	NA		
		Stairs/Ladders	4	Bottom ladder (same used for both tanks)	
		Hatches/Doors	NA		
		Supports	NA		
		Cathodic Prot.	NA

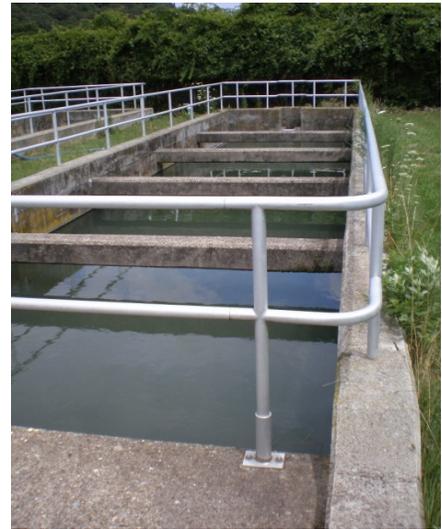
Structure Description Secondary Clarifier No. 1 (Older)  
 Use Settling  
 Type Of Construction Concrete  
 Year Built \_\_\_\_\_  
 LxWxH (above grade)     x    x      
 Basement Dimensions \_\_\_\_\_

<u>Condition</u>	1-5/NA	Comment(s)			
Concrete/Masonry	Corrosion		1				
	Leakage		1				
	Cracking		3				
	Spalling		3				
	Settling		1				
	Joint Damage/Failure		NA				
	Exposed Reinfcmnt/Aggreg.		1				
	Pitting		1				
	Delamination		1				
	Freeze/Thaw Damage		1				
						<b>Ancillary Items</b>	1-5/NA
					Railings	2	
Steel	Corrosion		NA		Walkways	NA	
	Loss of Section		NA		Platforms	3	
	Cracking		NA		Stairs/Ladders	NA	
	Deformation		NA		Hatches/Doors	NA	
	Fatigue		NA		Supports	NA	
	Connection Failure		NA		Cathodic Prot.	NA

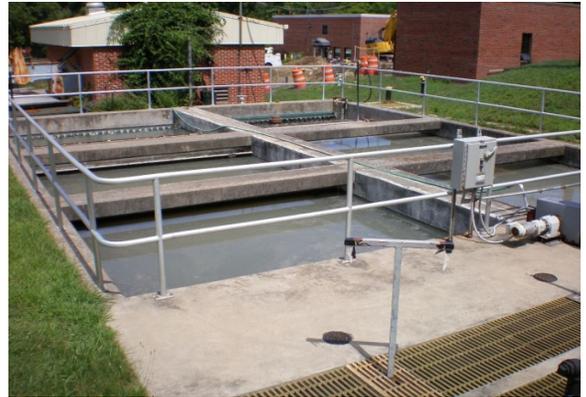
Structure Description	Primary Clarifier No. 2	
Use	Settling	
Type Of Construction	Concrete	
Year Built		
LxWxH (above grade)	x	x
Basement Dimensions

Condition	1-5/NA	Comment(s)			
Concrete/Masonry	Corrosion		1				
	Leakage		1				
	Cracking		1				
	Spalling		1				
	Settling		1				
	Joint Damage/Failure		NA				
	Exposed Reinfcmnt/Aggreg.		1				
	Pitting		1				
	Delamination		1				
	Freeze/Thaw Damage		1				
					<b>Ancillary Items</b>	1-5/NA	Comment(s)
				Railings	2		
Steel	Corrosion		NA		Walkways	NA	
	Loss of Section		NA		Platforms	1	
	Cracking		NA		Stairs/Ladders	NA	
	Deformation		NA		Hatches/Doors	NA	
	Fatigue		NA		Supports	NA	
	Connection Failure		NA		Cathodic Prot.	NA

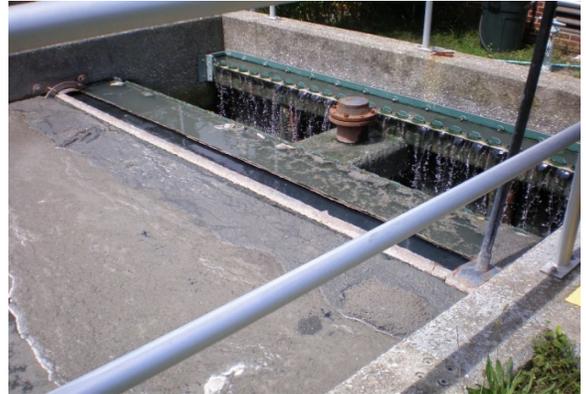
Structure Description Primary Clarifier No. 1 (Older)  
 Use Settling  
 Type Of Construction Concrete  
 Year Built \_\_\_\_\_  
 LxWxH (above grade)     x    x      
 Basement Dimensions \_\_\_\_\_

Condition	1-5/NA	Comment(s)			
Concrete/Masonry	Corrosion		1				
	Leakage		1				
	Cracking		2				
	Spalling		3				
	Settling		1				
	Joint Damage/Failure		NA				
	Exposed Reinfcmnt/Aggreg.		1				
	Pitting		1				
	Delamination		1				
	Freeze/Thaw Damage		1				
					<b>Ancillary Items</b>	1-5/NA	Comment(s)
Steel	Corrosion		NA		Railings	2	
	Loss of Section		NA		Walkways	NA	
	Cracking		NA		Platforms	2	
	Deformation		NA		Stairs/Ladders	NA	
	Fatigue		NA		Hatches/Doors	NA	
	Connection Failure		NA		Supports	NA	
					Cathodic Prot.	NA

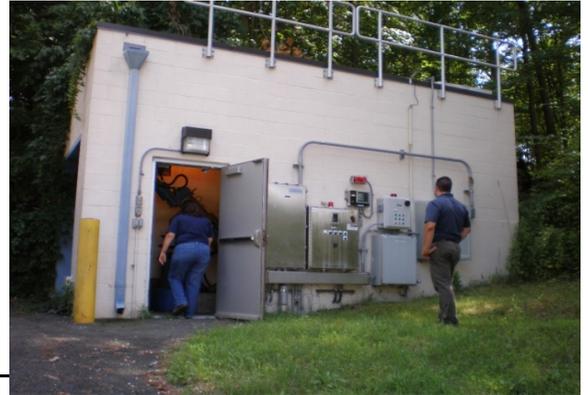
Structure Description	<u>Bedford Screening Bldg</u>
Use	<u>Raw sewage screening</u>
Type Of Construction	<u>Block</u>
Year Built	_____
LxWxH (above grade)	_____ x _____
Basement Dimensions	_____

<b>Condition</b>	1-5/NA	Comment(s)			
Concrete/Masonry	Corrosion		1				
	Leakage		1				
	Cracking		1				
	Spalling		1				
	Settling		1				
	Joint Damage/Failure		1				
	Exposed Reinfcmnt/Aggreg.		1				
	Pitting		1				
	Delamination		1				
	Freeze/Thaw Damage		1				
					<b>Wood</b>	1-5/NA	Comment(s)
				Dry Rot	NA		
				Warping	NA		
				Splitting	NA		
				Conn. Failure	NA		
				Loss of Section	NA		
				<b>Ancillary Items</b>	1-5/NA	Comment(s)	
				Roof	1		
Steel	Corrosion		NA		Railings	NA	
	Loss of Section		NA		Walkways	NA	
	Cracking		NA		Platforms	NA	
	Deformation		NA		Stairs/Ladders	NA	
	Fatigue		NA		Hatches/Doors	2	
	Connection Failure		NA		Fences	NA

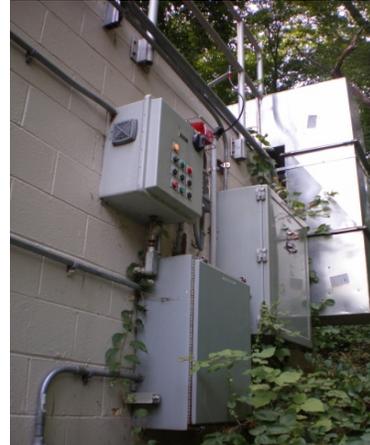
Structure Description	Taconic Screening Bldg	
Use	Raw sewage screening	
Type Of Construction	Block	
Year Built	_____	
LxWxH (above grade)	x	x
Basement Dimensions	_____

Condition	1-5/NA	Comment(s)			
Concrete/Masonry	Corrosion		1				
	Leakage		1				
	Cracking		1		<b>Wood</b>	1-5/NA	Comment(s)
	Spalling		1		Dry Rot	NA	
	Settling		1		Warping	NA	
	Joint Damage/Failure		1		Splitting	NA	
	Exposed Reinfcmnt/Aggreg.		1		Conn. Failure	NA	
	Pitting		1		Loss of Section	NA	
	Delamination		1		<b>Ancillary Items</b>	1-5/NA	Comment(s)
	Freeze/Thaw Damage		1		Roof	1	
	Steel	Corrosion		NA		Railings	NA
Loss of Section			NA		Walkways	NA	
Cracking			NA		Platforms	NA	
Deformation			NA		Stairs/Ladders	NA	
Fatigue			NA		Hatches/Doors	2	
Connection Failure			NA		Fences	NA

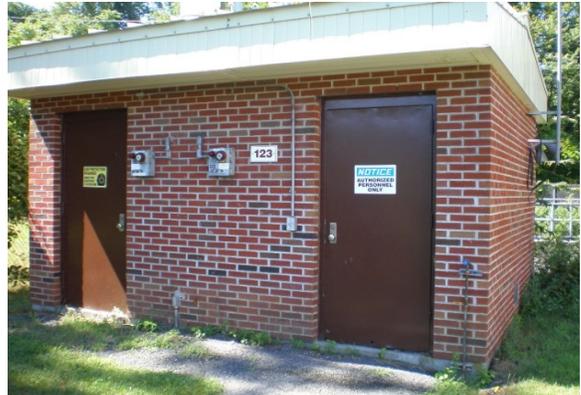
Structure Description	Blower/ MLP Control Bldg	
Use	EQ Blower/ Influent Pump Control Room	
Type Of Construction	Brick/Block	
Year Built		
LxWxH (above grade)	x	x
Basement Dimensions

Condition	1-5/NA	Comment(s)
Concrete/Masonry	Corrosion		1	
	Leakage		1	
	Cracking		1	
	Spalling		1	
	Settling		1	
	Joint Damage/Failure		1	
	Exposed Reinfcmnt/Aggreg.		1	
	Pitting		1	
	Delamination		1	
	Freeze/Thaw Damage		1	
Steel	Corrosion		NA	
	Loss of Section		NA	
	Cracking		NA	
	Deformation		NA	
	Fatigue		NA	
	Connection Failure		NA	
		<b>Wood</b>	1-5/NA	Comment(s)
		Dry Rot	NA	
		Warping	NA	
		Splitting	NA	
	Conn. Failure	NA		
	Loss of Section	NA		
	<b>Ancillary Items</b>	1-5/NA	Comment(s)	
	Roof	1		
	Railings	NA		
	Walkways	NA		
	Platforms	NA		
	Stairs/Ladders	NA		
	Hatches/Doors	4	Two doors	
	Fences	Na

Equipment Exceptions: 1-5  
Doors need replacement

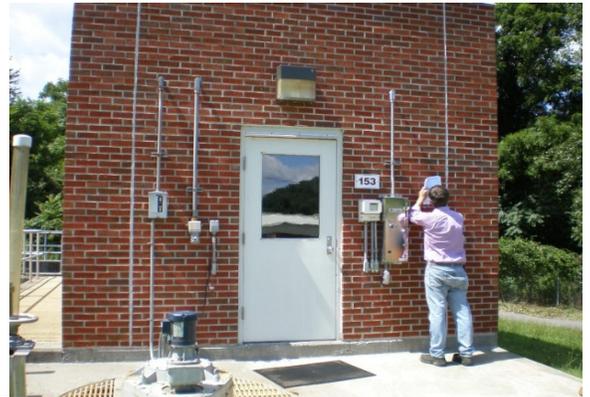
Structure Description	Grit/ Headworks Bldg	
Use	Influent Pumps/ Grit Removal	
Type Of Construction	Brick/ Block	
Year Built	_____	
LxWxH (above grade)	x	x
Basement Dimensions	_____

Condition	1-5/NA	Comment(s)		
Concrete/Masonry	Corrosion		1			
	Leakage		1			
	Cracking		1			
	Spalling		1			
	Settling		1			
	Joint Damage/Failure		1			
	Exposed Reinfcmnt/Aggreg.		1			
	Pitting		1			
	Delamination		1			
	Freeze/Thaw Damage		1			
					<b>Wood</b>	1-5/NA
				Dry Rot	NA	
				Warping	NA	
				Splitting	NA	
				Conn. Failure	NA	
				Loss of Section	NA	
				<b>Ancillary Items</b>	1-5/NA	Comment(s)
				Roof	1	
				Railings	2	
				Walkways	2	Joints need caulking
				Platforms	NA	
				Stairs/Ladders	2	
				Hatches/Doors	2	
				Fences	NA	
Steel	Corrosion		NA			
	Loss of Section		NA			
	Cracking		NA			
	Deformation		NA			
	Fatigue		NA			
	Connection Failure		NA

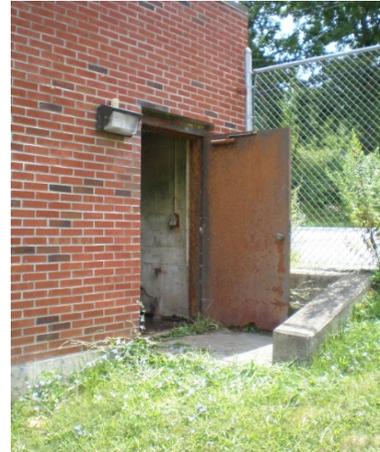
Structure Description	Screening Bldg	
Use	Screening	
Type Of Construction	Brick/ Block	
Year Built		
LxWxH (above grade)	x	x
Basement Dimensions

Condition	1-5/NA	Comment(s)	
Concrete/Masonry	Corrosion		2		
	Leakage		2		
	Cracking		2		
	Spalling		2		
	Settling		2		
	Joint Damage/Failure		1		
	Exposed Reinfcmnt/Aggreg.		1		
	Pitting		2		
	Delamination		1		
	Freeze/Thaw Damage		1		
	Steel	Corrosion		NA	
Loss of Section			NA		
Cracking			NA		
Deformation			NA		
Fatigue			NA		
Connection Failure			NA		
				<b>Wood</b>	
			1-5/NA	Comment(s)	
			NA	Dry Rot	
			NA	Warping	
			NA	Splitting	
		NA	Conn. Failure		
		NA	Loss of Section		
				<b>Ancillary Items</b>	
		1-5/NA	Comment(s)		
		1	Roof		
		NA	Railings		
		NA	Walkways		
		NA	Platforms		
		NA	Stairs/Ladders		
		5	Hatches/Doors		
		NA	Fences

1-5	
5	Doors need replacement

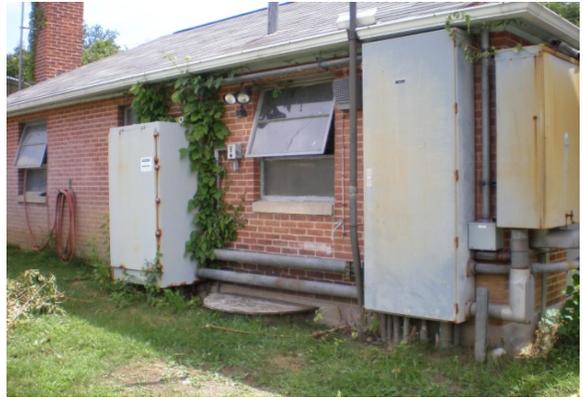
Structure Description	Control Bldg	
Use	Sludge Pumps, Chemicals, Trickling Filter Feed Pumps, Lab	
Type Of Construction	Brick	
Year Built		
LxWxH (above grade)	x	x
Basement Dimensions

Condition	1-5/NA	Comment(s)
Concrete/Masonry	Corrosion		2	
	Leakage		2	
	Cracking		2	
	Spalling		2	
	Settling		2	
	Joint Damage/Failure		1	
	Exposed Reinfcmnt/Aggreg.		1	
	Pitting		2	
	Delamination		1	
	Freeze/Thaw Damage		1	
Steel	Corrosion		NA	
	Loss of Section		NA	
	Cracking		NA	
	Deformation		NA	
	Fatigue		NA	
	Connection Failure		NA	
		<b>Wood</b>	1-5/NA	Comment(s)
		Dry Rot	NA	
		Warping	NA	
		Splitting	NA	
	Conn. Failure	NA		
	Loss of Section	NA		
	<b>Ancillary Items</b>	1-5/NA	Comment(s)	
	Roof	2		
	Railings	3		
	Walkways	NA		
	Platforms	NA		
	Stairs/Ladders	2		
	Hatches/Doors	2	Two doors	
	Fences	NA

Comments: Brick chimney needs repointing  
 Broken windows

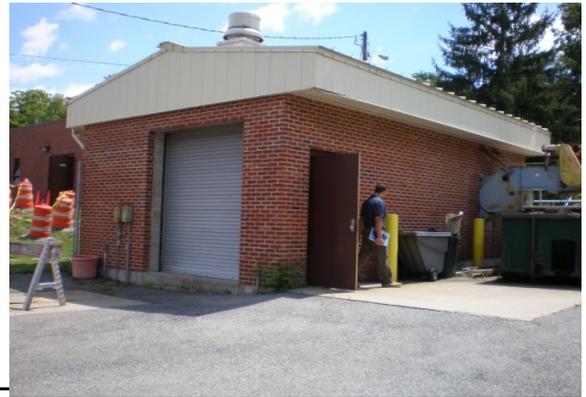
Structure Description	Belt Filter Press Bldg	
Use	Sludge dewatering	
Type Of Construction	Brick/ Block	
Year Built	_____	
LxWxH (above grade)	x	x
Basement Dimensions	_____

Condition	1-5/NA	Comment(s)			
Concrete/Masonry	Corrosion		1				
	Leakage		1				
	Cracking		1				
	Spalling		1				
	Settling		1				
	Joint Damage/Failure		1				
	Exposed Reinfcmnt/Aggreg.		1				
	Pitting		1				
	Delamination		1				
	Freeze/Thaw Damage		1				
					<b>Wood</b>	1-5/NA	Comment(s)
				Dry Rot	NA		
				Warping	NA		
				Splitting	NA		
				Conn. Failure	NA		
				Loss of Section	NA		
				<b>Ancillary Items</b>	1-5/NA	Comment(s)	
				Roof	1		
Steel	Corrosion		NA		Railings	NA	
	Loss of Section		NA		Walkways	NA	
	Cracking		NA		Platforms	NA	
	Deformation		NA		Stairs/Ladders	NA	
	Fatigue		NA		Hatches/Doors	2	
	Connection Failure		NA		Fences	NA

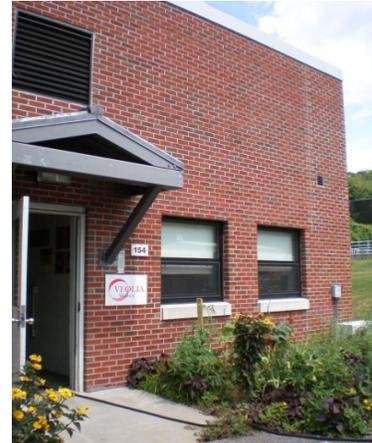
Structure Description	Microfiltration Building	
Use	UV / Filtration	
Type Of Construction	Brick/ Block	
Year Built	_____	
LxWxH (above grade)	x	x
Basement Dimensions	_____

Condition	1-5/NA	Comment(s)			
Concrete/Masonry		Corrosion	1				
		Leakage	1				
		Cracking	1		<b>Wood</b>	1-5/NA	Comment(s)
		Spalling	1		Dry Rot	NA	
		Settling	1		Warping	NA	
		Joint Damage/Failure	1		Splitting	NA	
		Exposed Reinfcmnt/Aggreg.	1		Conn. Failure	NA	
		Pitting	1		Loss of Section	NA	
		Delamination	1		<b>Ancillary Items</b>	1-5/NA	Comment(s)
		Freeze/Thaw Damage	1		Roof	1	
	Steel		Corrosion	1		Railings	NA
		Loss of Section	1		Walkways	NA	
		Cracking	1		Platforms	NA	
		Deformation	1		Stairs/Ladders	NA	
		Fatigue	1		Hatches/Doors	1	
		Connection Failure	1		Fences	NA

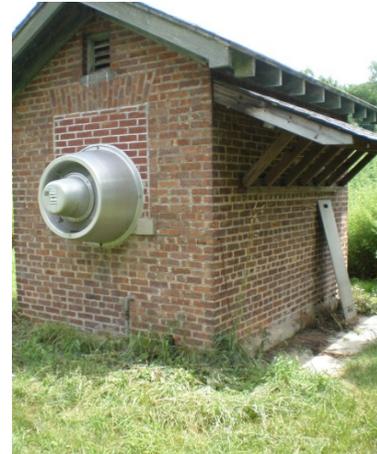
Structure Description	Standby Chlorine Bldg	
Use	Not in Use	
Type Of Construction	Brick	
Year Built		
LxWxH (above grade)	x	x
Basement Dimensions

Condition	1-5/NA	Comment(s)			
Concrete/Masonry	Corrosion		3				
	Leakage		3				
	Cracking		3		<b>Wood</b>	1-5/NA	Comment(s)
	Spalling		3		Dry Rot	4	Roof
	Settling		3		Warping		
	Joint Damage/Failure		NA		Splitting	4	Roof area
	Exposed Reinfcmnt/Aggreg.		NA		Conn. Failure		
	Pitting		NA		Loss of Section		
	Delamination		NA		<b>Ancillary Items</b>	1-5/NA	Comment(s)
	Freeze/Thaw Damage		NA		Roof	4	Slate roof missing some tiles
Steel	Corrosion		NA		Railings	NA	
	Loss of Section		NA		Walkways	NA	
	Cracking		NA		Platforms	NA	
	Deformation		NA		Stairs/Ladders	NA	
	Fatigue		NA		Hatches/Doors	3	
	Connection Failure		NA		Fences	NA
